FINAL DESIGN REPORT/ ENVIRONMENTAL ASSESSMENT (DR/EA) APPENDICES

East Midtown Waterfront Esplanade and Greenway
P.I.N. X776.00 and X770.14
East 41st Street to East 60th Street on East River,
New York City

APPENDIX A
CONCEPTUAL DESIGN PLANS
EXISTING SURVEY

EAST MIDTOWN WATERFRONT ESPLANADE CONCEPTUAL DESIGN PLANS

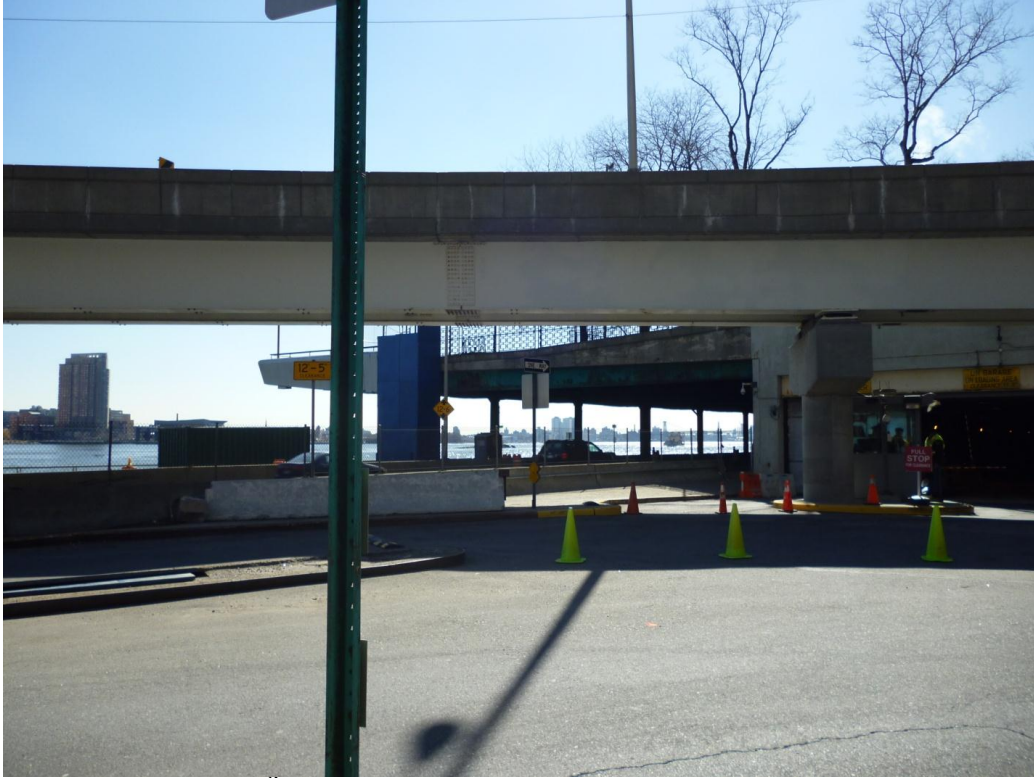
1
2
3
4
Photo 9 At the foot of East 48th Street at southbound FDR Drive exit ramp looking south at the elevated ramp structure. Note FDR underpass below UN Headquarters property in background.

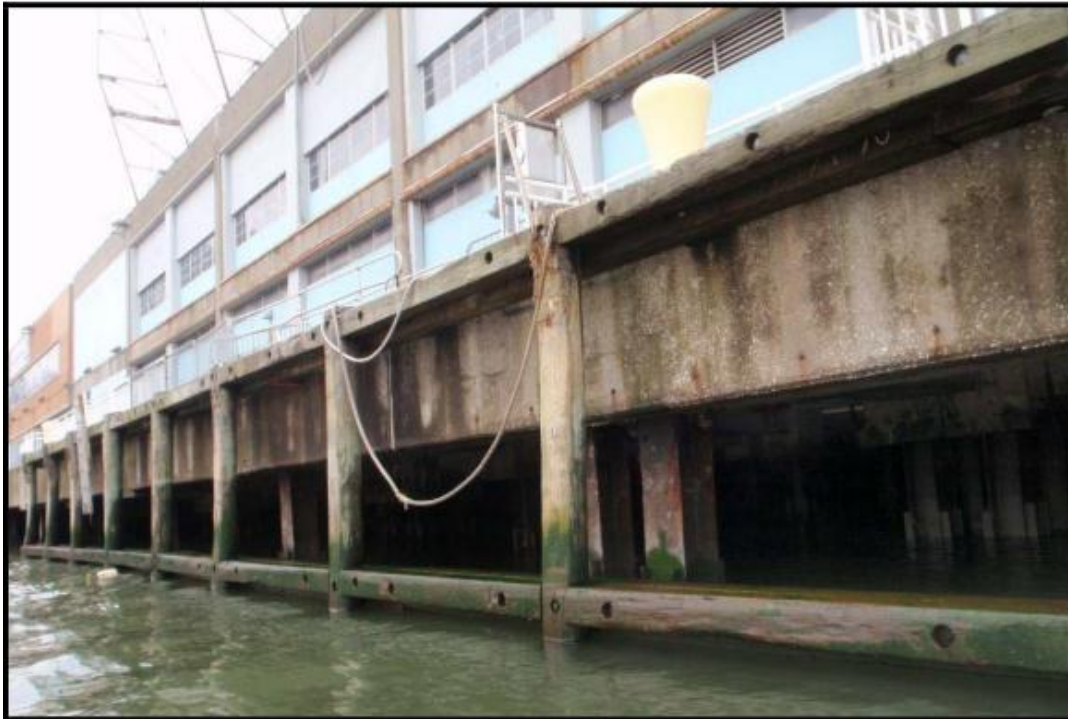
Photo 3: Pier 40. Note the numerous pilings and horizontal support members. Source: HPA Engineers P.C. 2009
